3000-HP ROLLER GEAR TRANSMISSION DEVELOPMENT PROGRAM. VOLUME III. ROLLER GEAR MANUFACTURE

3000-HP ROLLER GEAR TRANSMISSION DEVELOPMENT PROGRAM Volume III - Roller Gear Manufacture

Sikorsky Aircraft
Division of United Technologies Corporation
Stratford, Conn. 06602

Final Report

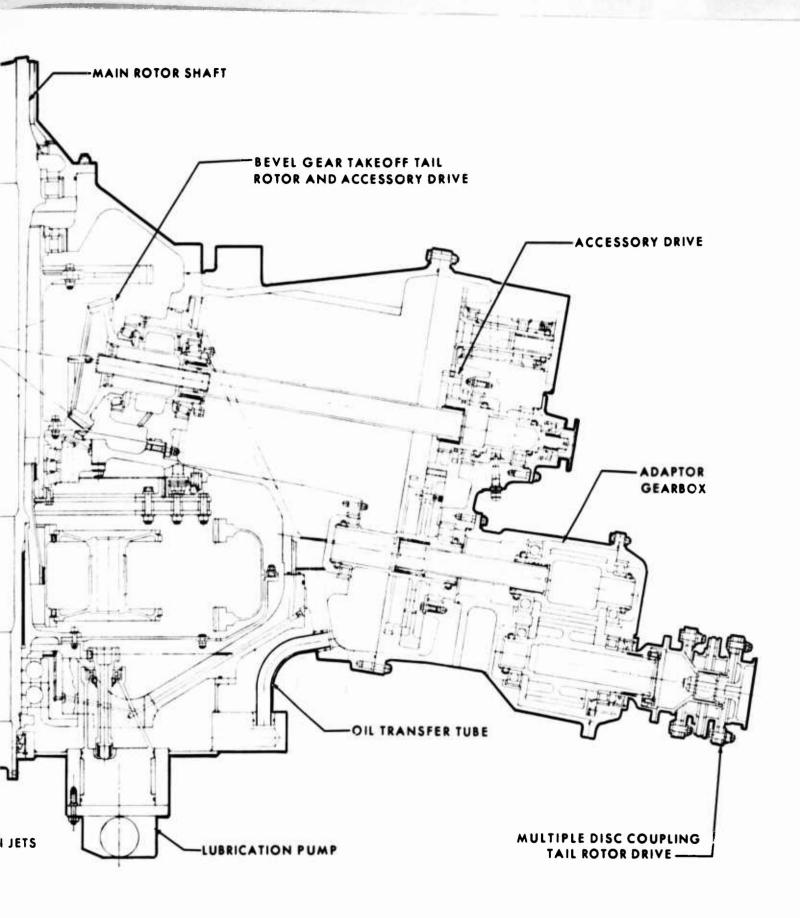
Figure 7. Roller Gear Transmission Freewheel Unit.

The ramp roller clutch type freewheel unit, shown in Figure 7, is located between the input bevel mesh and the combining spur mesh. This unit is in the driving mode when the engine tends to turn faster than the main rotor shaft. It is in the free-wheel mode when the main rotor shaft tends to turn faster than the engine. This clutch permits autorotation and single-engine operation without rotation of the other engine. It also acts as a safety device in the event of engine failure, by permitting safe descent by autorotation.

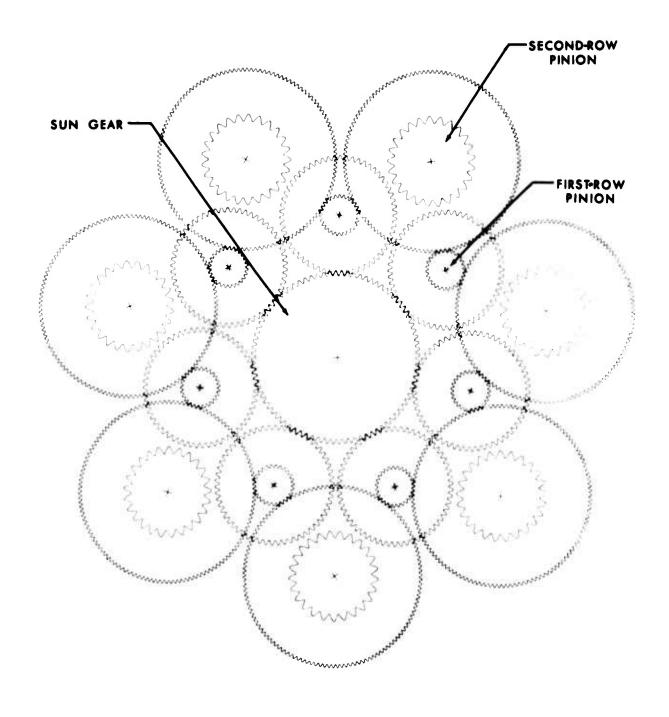
Figure 9. Roller Gear Component Arrangement.

A cross section of the roller gear drive is presented in Figure 8, while Figure 9 shows the roller gear component arrangement from the top. The sun gear is connected to the quill shaft by a floating spline and is supported in the axial direction by the rollers at the first-row pinions. The first-row pinion contains two outer spur gears which mate with the sun gear and an inner spur gear which mates with the second-row pinion. The first-row pinion is accurately positioned at one point on the inside by the sun gear and at two points on the outside by the

second-row pinions. This three-point support is inherently stable and dispenses with the need for bearing support. The inner rollers of the first-row pinions contain end flanges which constrain these pinions in the axial direction.

The second-row pinions are contacted at two inner points by the first-row pinions, and at one outer point by the ring gear. Spherical bearings are used to hold these pinions in place and to react torque through the gearbox. The internal clearances of these bearings are such that under the worst case of roller tolerances and defections, the bearings cannot react loads in the radial direction. Only tangential loads resulting from the reaction torque of the roller gear unit are reacted by these bearings. The split ring gear has no rollers since the resultant gear mesh load from the ring gear teeth on the second-row pinion teeth is radially loward. Basic data of the roller gear components is presented in Table 1.

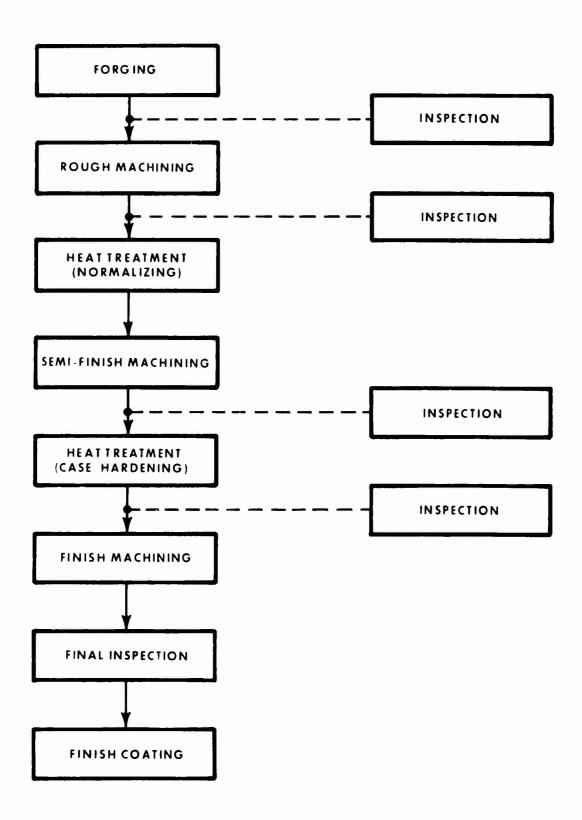
Figure 11. Basic Gear Manufacturing Process.

The manufacturing process from the gear forging to the finished gear is depicted in Figure 11.

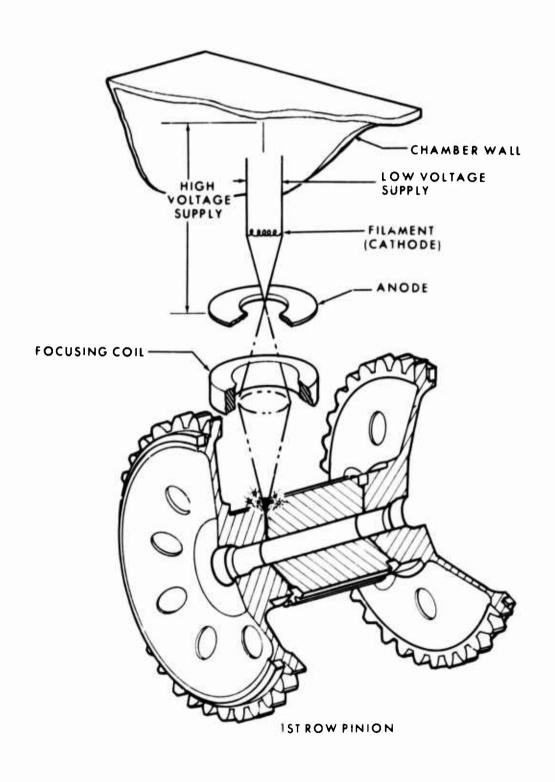
Figure 36. Electron Beam Welding Process, Schematic.

Although there are many advantages to electron beam welding, including weld integrity and speed, the most important considerations in choosing electron beam welding for roller gear manufacture were its minimal heat effect and its high depthto-width ratio. The fusion process occurs so rapidly with electron beam welding that very little heating occurs in the This means that there is very little, if surrounding metal. any, distortion of the welded part, a necessary condition for the close tolerances required by the roller gear components. In addition, the size of the heat affected zone, where the structure of the metal might be altered, is minimized. extremely small working area in the fabrication of the roller gear components necessitated a welding process with a high depthto-width ratio. Figure 37 shows a comparison of this parameter for electron beam and a typical tungsten inert gas (TIG) arc In most of the welds in the roller gear components there is a working width of less than 1/10 inch between the stressed surfaces of roller and gear which would tolerate little heating from the welding process. As will be seen later in this

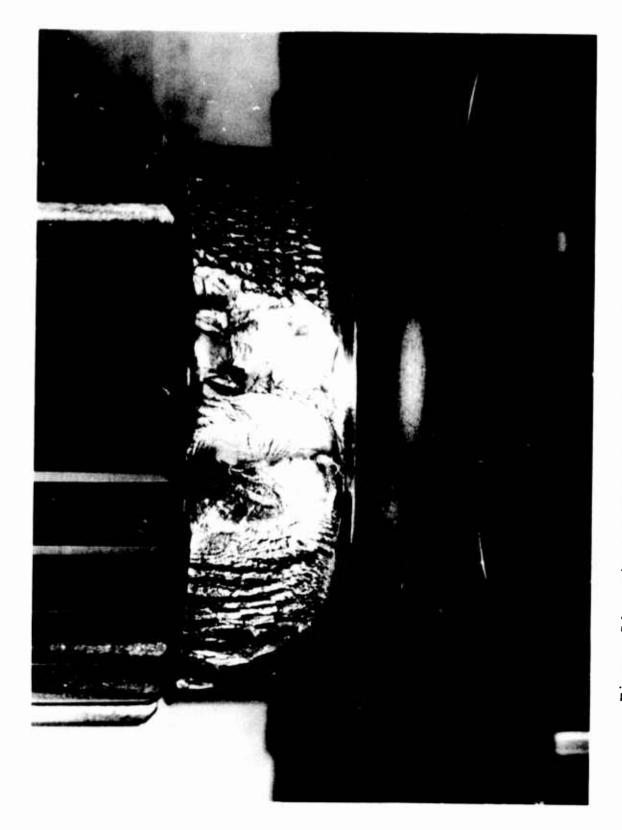
Figure 54. First-Row Pinion Small Diameter Roller Spalling.

The initial development test was performed in a back-to-back regenerative test stand capable of subjecting the gearboxes to an equivalent of 3500 HP. Only those aspects of the initial development test relating directly to electron beam welding development are discussed below. Figure 53 shows the bench test schedule, including both initial development test and endurance test, to which the roller gear transmission was subjected (Reference 5). At 26 hours 28 minutes into the initial development test, the rollers adjacent to the small diameter gear of the first-row pinions showed severe spalling (Figure 54).

Microscopic examination of a failed first-row pinion revealed that spalling of the small diameter gear's lower roller was caused by fatigue cracking originating below the surface and propagating to the surface. A cross-sectional sample taken in an unspalled area immediately adjacent to the spalling revealed a subsurface crack extending through the electron beam weld zone as shown in Figure 55. There was no evidence of this crack at the surface. Metallographic examination revealed a series of voids along the weld line as shown in Figure 56. Cracks were evident extending from one of these voids. Examination revealed a desired case microstructure of martensite and tempered austenite with no evidence of carbide network.

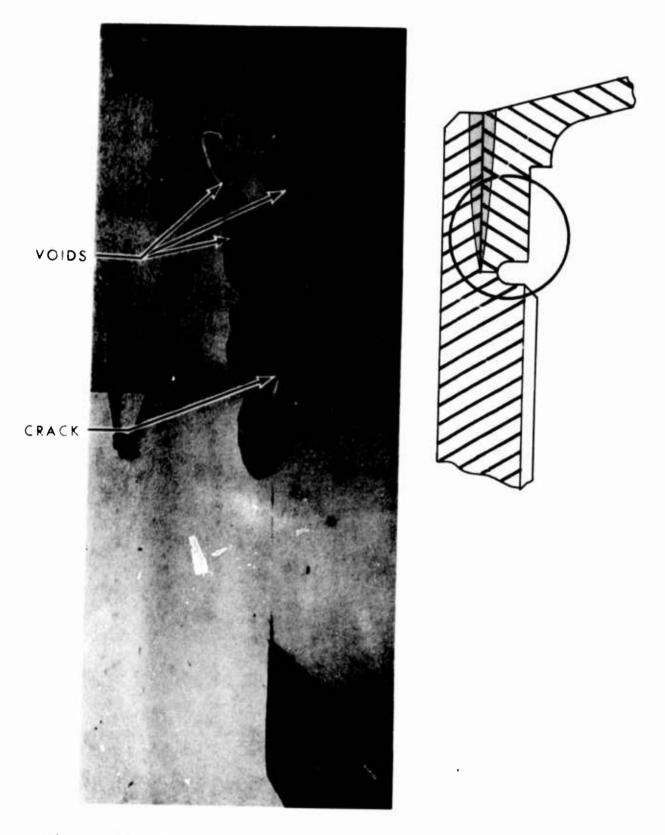
Figure 56. Metallographic Inspection of First-Row Pinions Revealing Voids at Weld Line.

A microhardness traverse through the core, in a direction normal to the surface, showed a slight reduction in hardness and effective case depth on both top and lower rollers. This plot is shown in Figure 57. This reduction is explained by the removal of stock during the final roller grinding operation and probably also the result of high temperatures generated during electron beam welding. The microhardness survey reveals a smooth transition from case to core with effective case depth measured at Rc 50. The low case hardness and depth were not considered factors in the spalling, since the cracking originated subsurface at voids in the weld.

It was concluded that the fracture initiated from voids in the area of the electron beam weld.

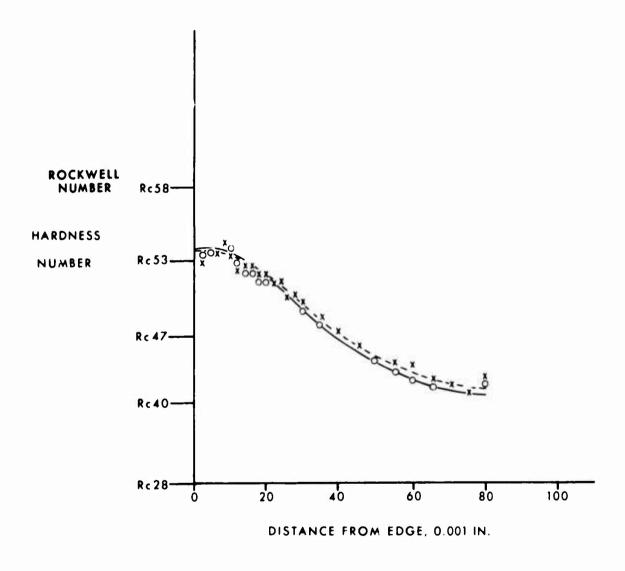
Figure 57. Microhardness Traverse Through Roller Core.

O — LOWER ROLLER X - - TOP ROLLER

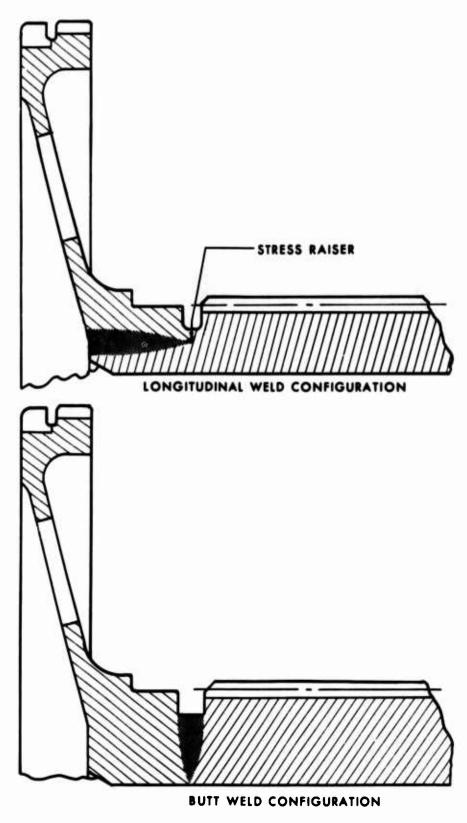
Figure 60. First-Row Pinion Weld Redesign.

In order to alleviate the problems described above, the first-row pinion was redesigned to include a butt weld instead of the original longitudinal weld. This weld configuration would require a decreased depth of penetration, thereby decreasing the chance of voids. Secondly, the weld would pass completely through the section of the pinion instead of ending in a blind. Visual inspection could then detect completeness of the weld which was impossible in the original configuration. In addition, the inherent stress concentration caused by the inner gear-roller interface, Figure 60, would be removed. The butt weld configuration would also have the advantage of being further removed from the compressively stressed material of the inner roller surface.

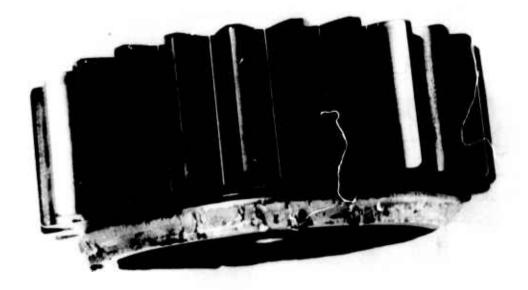
Second-Row Pinion (One of two ring gear mesh gears) Weld Separation. Figure 61.

The next welding related failure of a roller gear component occurred after 35 hours 58 minutes of testing with the fracture of a second-row pinion as shown in Figure 61. Inspection of the fractured second-row pinion revealed a machined surface

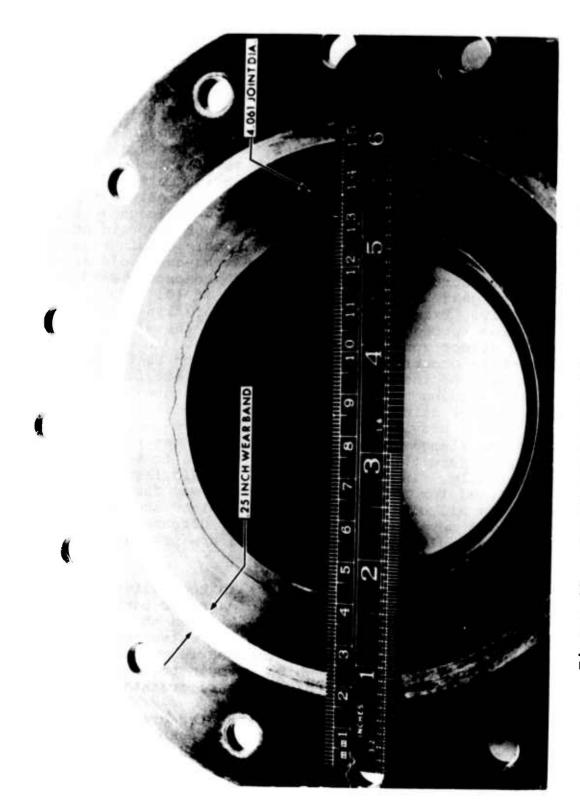
Figure 62. Second-Row Pinion Flange/Gear Weld Fracture.

approximately 0.090 inch wide and extending for approximately 50 percent of the circumference in the fractured area as indicated in Figure 62. This machined diameter is the electron beam weld joint face between the flange and the gear.

Metallurgical examination of the second-row gear assembly revealed a fracture in the weld area between the gear and flange extending for the entire circumference of the gear. Fracture examination revealed fatigue cracking originating at the end of the weld zone. Evident in the fracture is a machined surface. A cross-sectional sample through the weld revealed the weld beam had missed the joint between the mating components, as indicated in Figure 63. Examination revealed that while complete weld beam penetration had been accomplished, fusion had not occurred where the center of the weld beam missed the mating surfaces. Metallographic examination of the microstructure in this area revealed an as-cast weld zone of typical core structure in the mating components. Hardness of the flange, gear and weld zone measured Rc 40, 38 and 40, respectively. Examination of another gear/flange assembly shows a crack propagating from the end of the weld through the weld heat affect zone as seen in Figure 64. It was concluded that fracture occurred because of incomplete fusion on the blow-out side of the weld. To ensure complete fusion of this joint, the welding schedule was revised as shown in Table 9 to produce a wider joint. This required a modification to the gear so that a heavier blast shield could be positioned between the gear and flange to protect the finish gear from weld splatter. Figure 65 shows the modification to the second-row pinion assembly. In addition, an ultrasonic inspection technique used for the first-row pinions was further developed to encompass all electron beam welded joints and acceptance criteria were developed. The resulting ultrasonic inspection technique and weld acceptance criteria are presented in Appendix A.

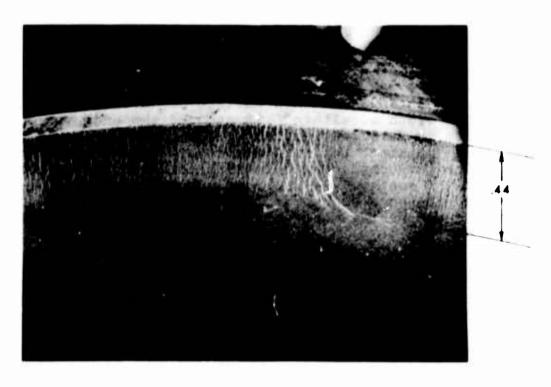
Figure 66. Longitudinal Cracking, Second-Row Pinion Bearing Bore

Prior to installation of these gears in the roller gear transmission, they were subjected to magnetic particle inspection which revealed longitudinal cracking on the inside diameter of the bearing bore, Figure 66, extending approximately 0.44 inch down from the mouth of the bearing bore. Examination of other second-row pinions, which were in the process of rework, revealed similarly located indications of cracking.

Metallurgical examination revealed that the cracks were multiple in nature and typical of cracks associated with grinding stresses. Several assemblies evidenced a series of deeper circumferential cracks extending for approximately 1.5 inches in length as shown in Figure 67. Examination of cross-sectional metallurgical specimens revealed the longitudinal cracks to be between 0.0007-0.001 inch deep. The

Since the indications occurred in an area of redundant load support structure, removal of the cracked metal by machining would not be detrimental to the life or function of the part. On this basis the cracks were removed by machining 0.040 inch off the bore diameter for a depth of 0.50 inch. An extended stress relieving cycle, in which the parts were subjected to a 23-hour bake at 325°F, was conducted to alleviate any residual stresses that could have formed during the rework.

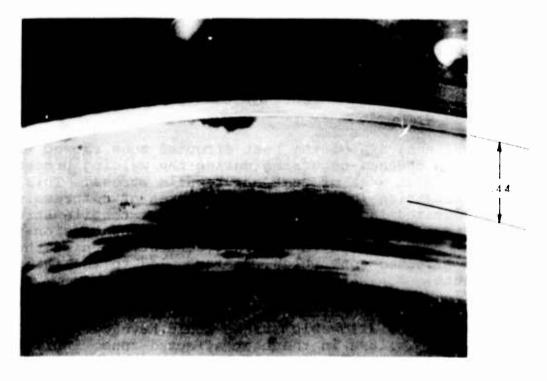
Figure 67. Circumferential Cracking, Second-Row Pinion Bearing Bore.

circumferential cracks measured approximately 0.025-0.030 inch deep. All of the cracking was confined to a band 0.44 inch wide which coincided with the weld zone which is located below this area. There was no cracking evident on the remaining surface area. Hardness of this surface measured uniformly Rc 56 across the width to within 0.25 inch of the edge where a hardness loss to Rc 50 was evident. The time span between the completion of manufacture, when magnetic particle inspection had last been performed, and detection of the cracking was approximately 6 months. It was concluded that cracking of these second-row gear assemblies was caused by residual stresses induced during manufacture, probably during the welding operation.

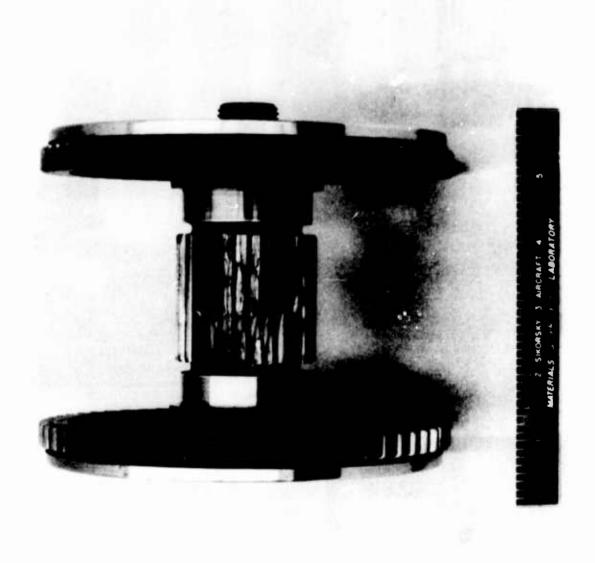
Figure 68. First-Row Pinion Tooth Fracture.

After 56 hours 56 minutes of initial development testing, another weld related failure occurred with the fracture of gear teeth on the small diameter gear of the first-row pinion, as shown in Figure 68. Inspection of the fractured first-row pinion teeth revealed that the cracking had originated near the roots of the teeth where the heat affected zone adjacent to the weld had extended into the gear root, Figure 69. The hardness readings, taken in the vicinity of the fracture origin, are shown in Figure 70.

Metallurgical analysis of the heat affected zone showed that transformation changes occurring during the welding process had resulted in an area of residual tensile stress. This created a transition interface where an area of compressive stress (carburized layer) bordered an area of tensile stress. This transition in the material, from a state of tension to a state of compression, led to a stress concentration at the edge of the heat affected zone which, in turn, led to the failure of the gear teeth.

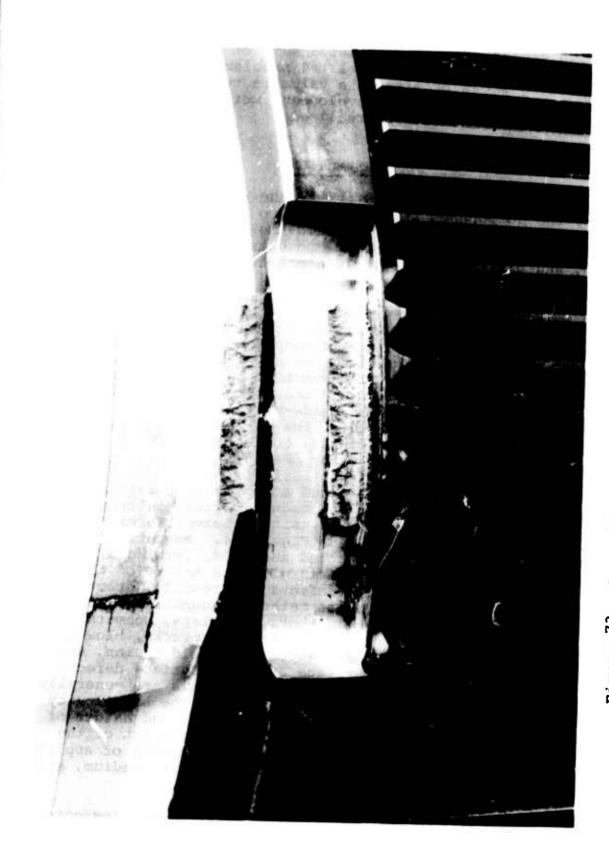
Second-Row Pinion Lower Roller Weld Cracking. Figure 73.

Another new set of roller gear components was used in the 50-hour aircraft tiedown test. The second-row pinions, although they gave no indication of failure during the test, showed indications of cracking on the ultrasonic inspection following the tiedown test. This is shown clearly by Figure 72, which shows the "C" scan of the lower roller of a second-row pinion (Serial Number 63) both before and after the 50-hour tiedown test. Remarkably similar indications were also evident on the other second-row pinions used in the tiedown test. Machining of the roller surface indicated by the "C" scan of Serial Number 63 revealed the crack shown in Figure 73. Metallurgical examination revealed that the fracture initiated at the exit side of the weld in the area of weld overlap. The cracking was caused by residual stresses from the welding cycle. It was discovered that these seven second-row pinions were allowed to sit at ambient air temperature for 24 hours after welding before being sent through the stress relief heat treat. the other second-row pinions were subjected to stress relief heat treat immediately after welding. It is believed that this was a factor in the cracking of the lower roller welds of these pinions.

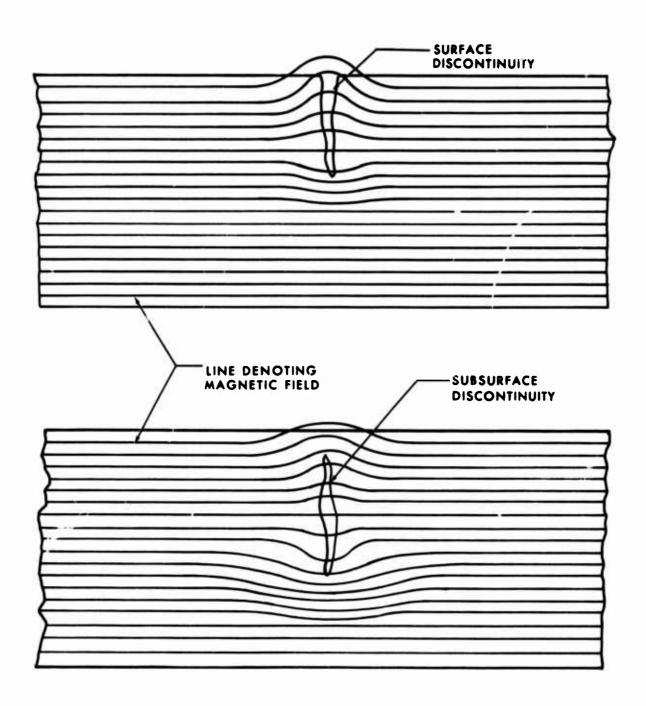
Figure 74. Effect of Discontinuities on Magnetic Field.

All of the components of the roller gear drive were inspected by the wet continuous method. In the application of this

method, the part is covered completely with fluorescent magnetic particles suspended in a liquid while the magnetizing current is flowing. The fluid flow is then cut off just before the current flow to prevent any flushing off of the magnetic particles which may have gathered because of flux leakage. This type of magnetic-particle inspection is the most sensitive to detection of flaws in the metal.

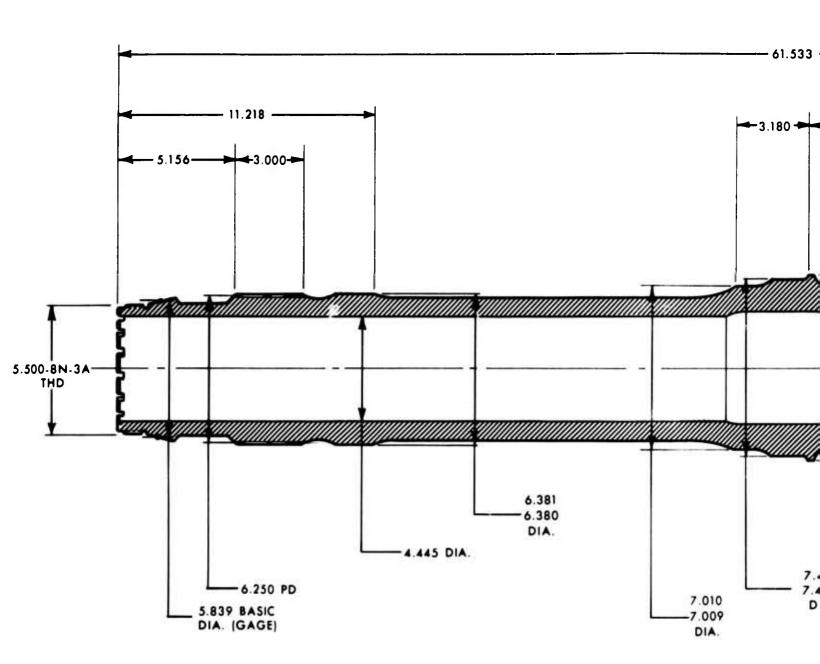
Figure 106. Main Rotor Shaft.

After heat treatment, the shaft is finish machined on both the inside and outside diameters. The splines are then hobbed with a vertical hobber. The final step is the coating of the inside of the shaft with a baked resin. Finished shaft dimensions are shown in Figure 106.

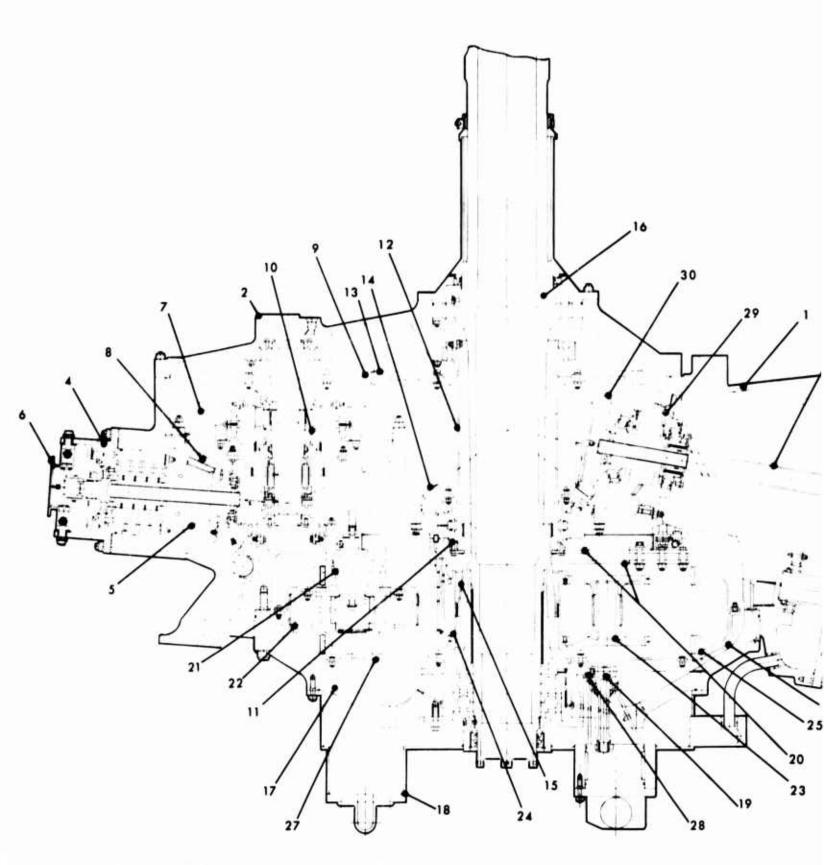
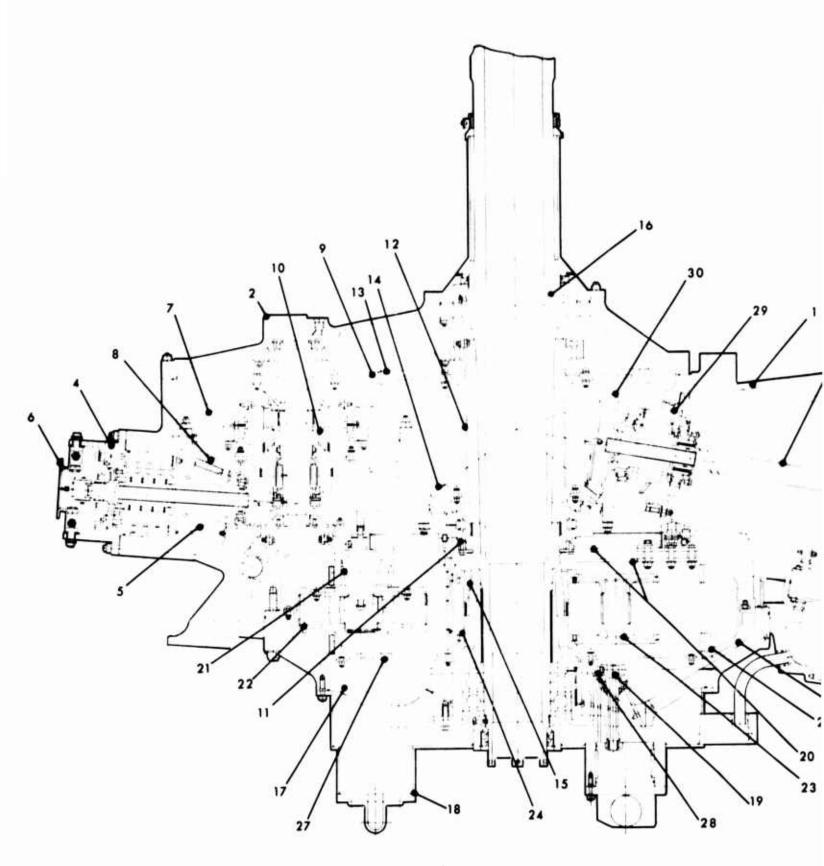
Figure B-1. Major Component Locations, Roller Gear Transmission.

TABLE B-1.	Continued			
Nomenclature	Item Number*	Quantity Per Gearbox		
Sun Gear	24	1		
Ring Gear Set	25	1		
Output Flange	26	1		
Spline - Plate	27	1		
Gear, Oil Pump Drive Sump	28	1		
Housing & Liner Ass'y T. T. O.	29	1		
Gear Bevel Pinion T. T. O.	30	1		
Quill T. T. O.	31	1		
Gear Sput T. T. O.	32	1 .		
Gear Sput T. T. O.	33	1		
Quill T. T. O.	34	1		
Gear Generator	35	1		
Housing Ass'y, Adaptor Box	36	1		
Cover Ass'y Box	37	1		
Spur - Input	38	1		
Spur Output	39	1		
Flange T. T. O.	40	1		
Coupling T. T. O.	41	1		
*Item numbers refer to Figure B-1.

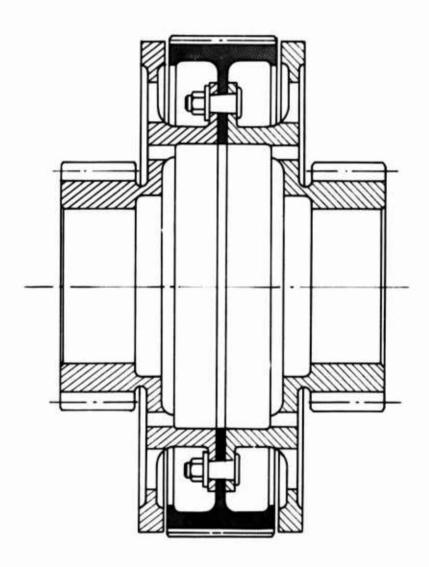
Figure D-1. Second-Row Pinion RG351-11278.

This appendix routes the manufacturing process of the second-row pinion matched set assembly, RG351-11278-041. This set, comprising of seven -042 pinions (Figure D-1), is a redesigned version of the second-row pinion RG351-11181 for which the manufacturing process routing is given in the previous appendix.
